Manhole Inspection Summary

Manhole # S45EE_006MH

Insp Date: **3/10/08 1:25 PM**

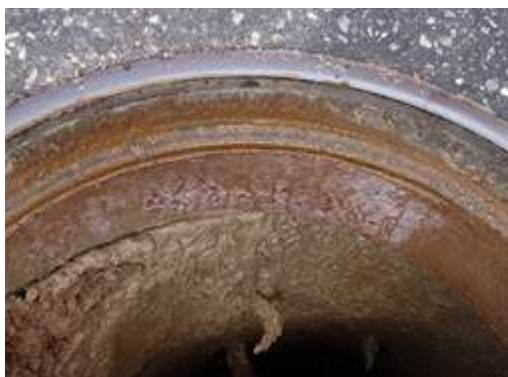
Defect 1

Condition: ☐ Sound ☐ Cracked ☐ Root Intrusion ☒ **Loose Brick** ☐ Deteriorated

Infiltration: ☐ None ☐ Joint ☐ Cracks ☐ Mortar ☐ Roots ☒ **Wall**

adjustment joint

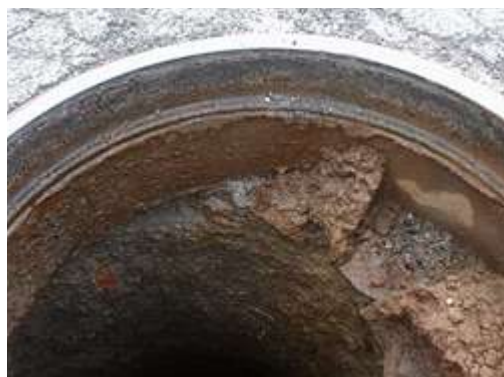
Defect 2

Frame Offset: **6** (in.) Condition: ☐ Sound ☐ Cracked ☒ **Leaks**

offset

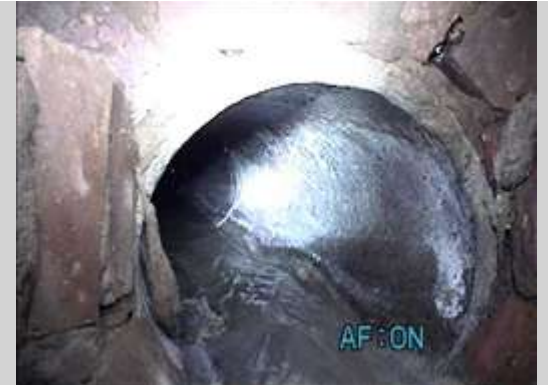
12 O'Clock Outflow

8 in. Circular Gravity Sewer
Pipe Out @ 12 O'Clock

Pipe Height: **8.4** (in.) Rod and Bar (Angled)
Pipe Material: **Clay** ☐ Pipe Lined
Invert Depth: **11.40** (ft.) Flow Characteristics: **Fast**
Deposits: ☒ None ☐ Mud ☐ ~~Gravy~~ ☐ Debris ☐ Grease
Silt Depth: (in.) Deposits Extent:
Infiltration: **None** Pipe Seal Cond: **Sound**

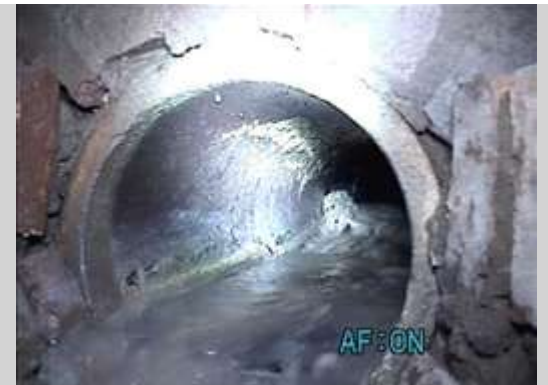
9 O'Clock Inflow

8 in. Circular Gravity Sewer
Pipe In @ 9 O'Clock

Pipe Height: **8.4** (in.) Rod and Bar (Angled)
Pipe Material: **Clay** ☐ Pipe Lined
Invert Depth: **11.30** (ft.) Flow Characteristics: **Fast**
Deposits: ☐ None ☐ Mud ☒ ~~Gravy~~ ☒ Debris ☐ Grease
Silt Depth: **1** (in.) Deposits Extent: **Light**
Infiltration: **None** Pipe Seal Cond: **Sound**
